Softbody Impact Resistance of Beryllium/Titanium Composite Blades

Detroit Diesel Allison
Division of General Motors Corporation
Indianapolis, Ind. 46241

May 1976

TECHNICAL REPORT AFAPL-TR-76-69
Final Report for Period July 1975 - March 1976

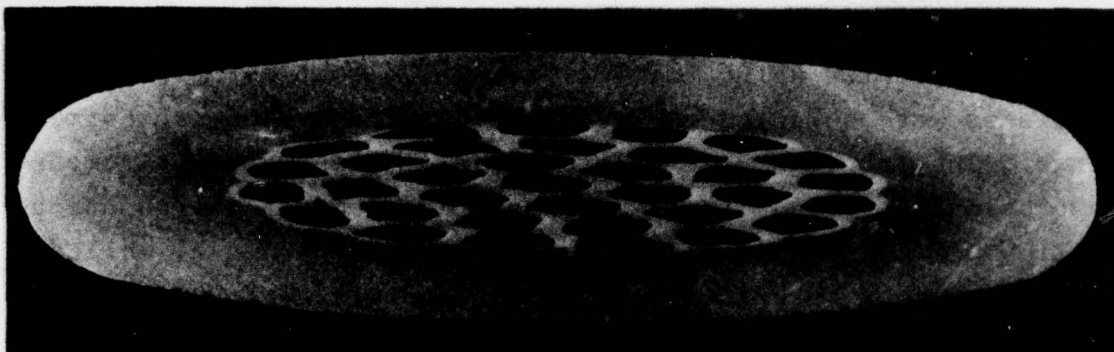
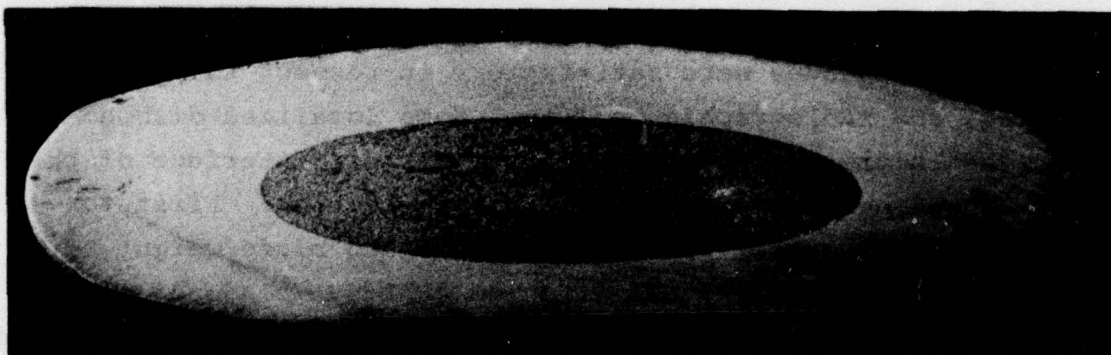
Figure 1. Macrostructures of Be/Ti composite extrusions fabricated from (a) continuous Be rods with wrought Ti and (b) Be and Ti powders (Mag. 2 1/2 X) (Keller's Etch)

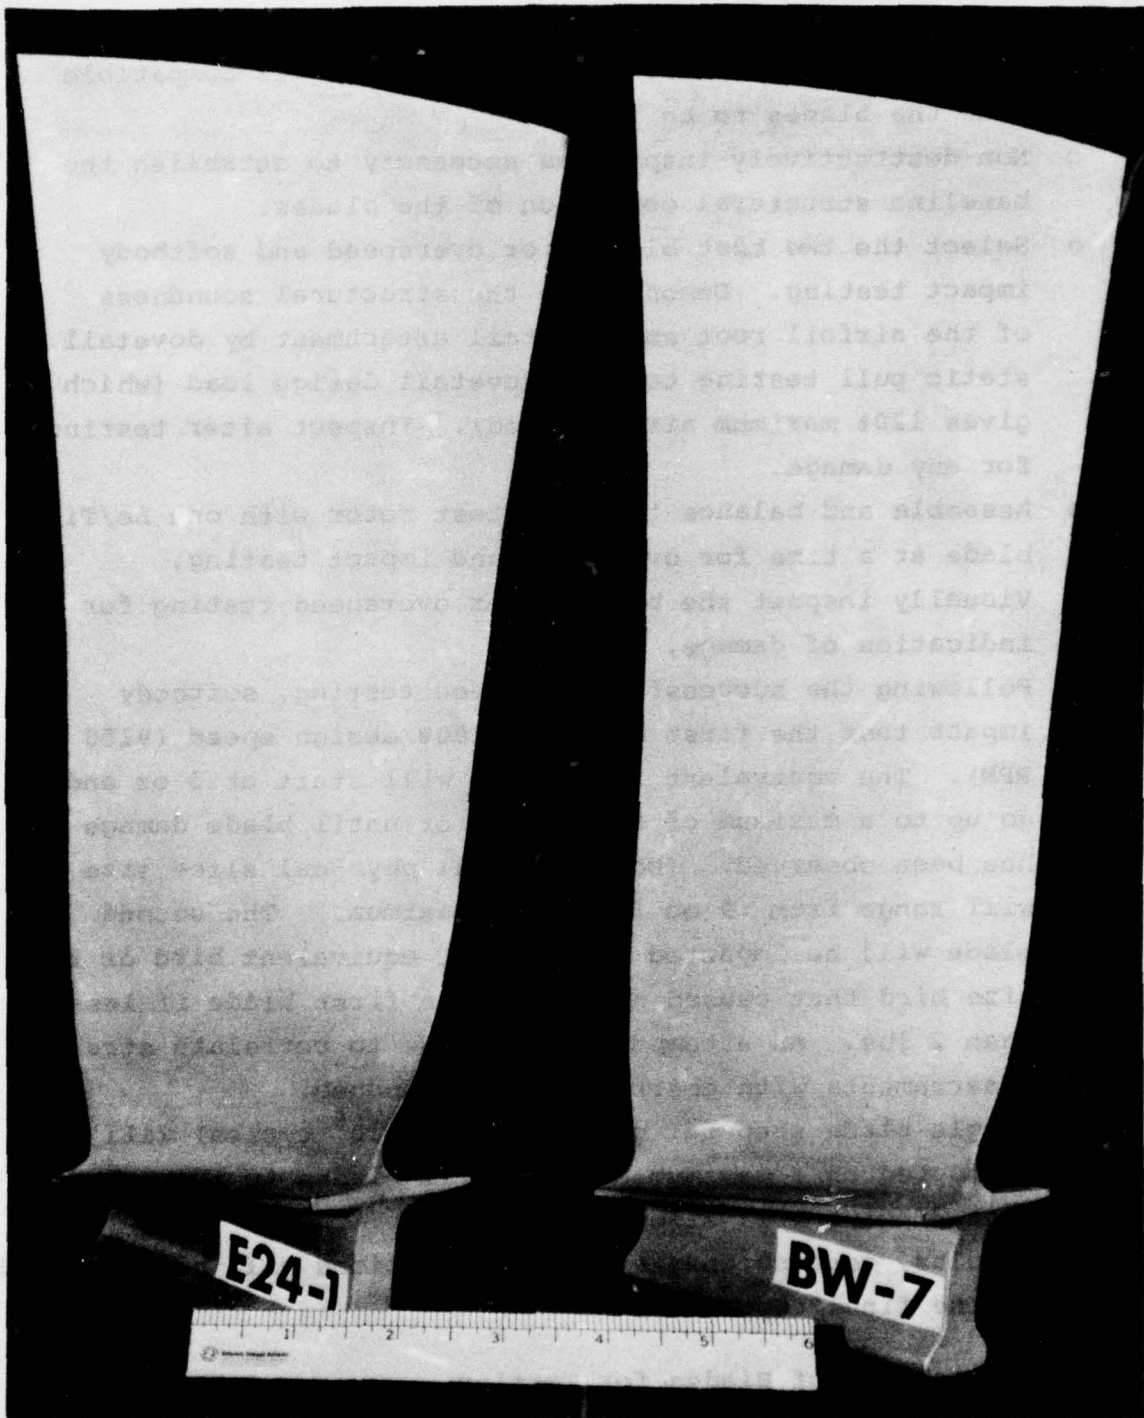
Two of the finished machined Be/Ti blades are shown in Figure 2. All seven of the blades were satisfactory in respect to visual, dimensional, and radiographic quality. Some localized disbond was observed in the root block-composite airfoil interface of the blades as shown by fluorescent penetrant inspection. First torsional resonant frequency was increased 11% and blade weight reduced 9%, compared to the all titanium (6AL-4V) blade of the same basic design. Tensile properties and metallographic structures were determined from one blade forging of each type composite material. Tensile strengths of the Be/Ti rod composite airfoil ranged from 90-91 ksi and the Be/Ti powder composite airfoil produced strengths of 46-67 ksi.

Figure 2. Finish machined TF41 Be/Ti Composite LP-1 Fan Blades
S/N E24-1 (Be Rod/Ti) and BW-7 (Powder Be/Ti).

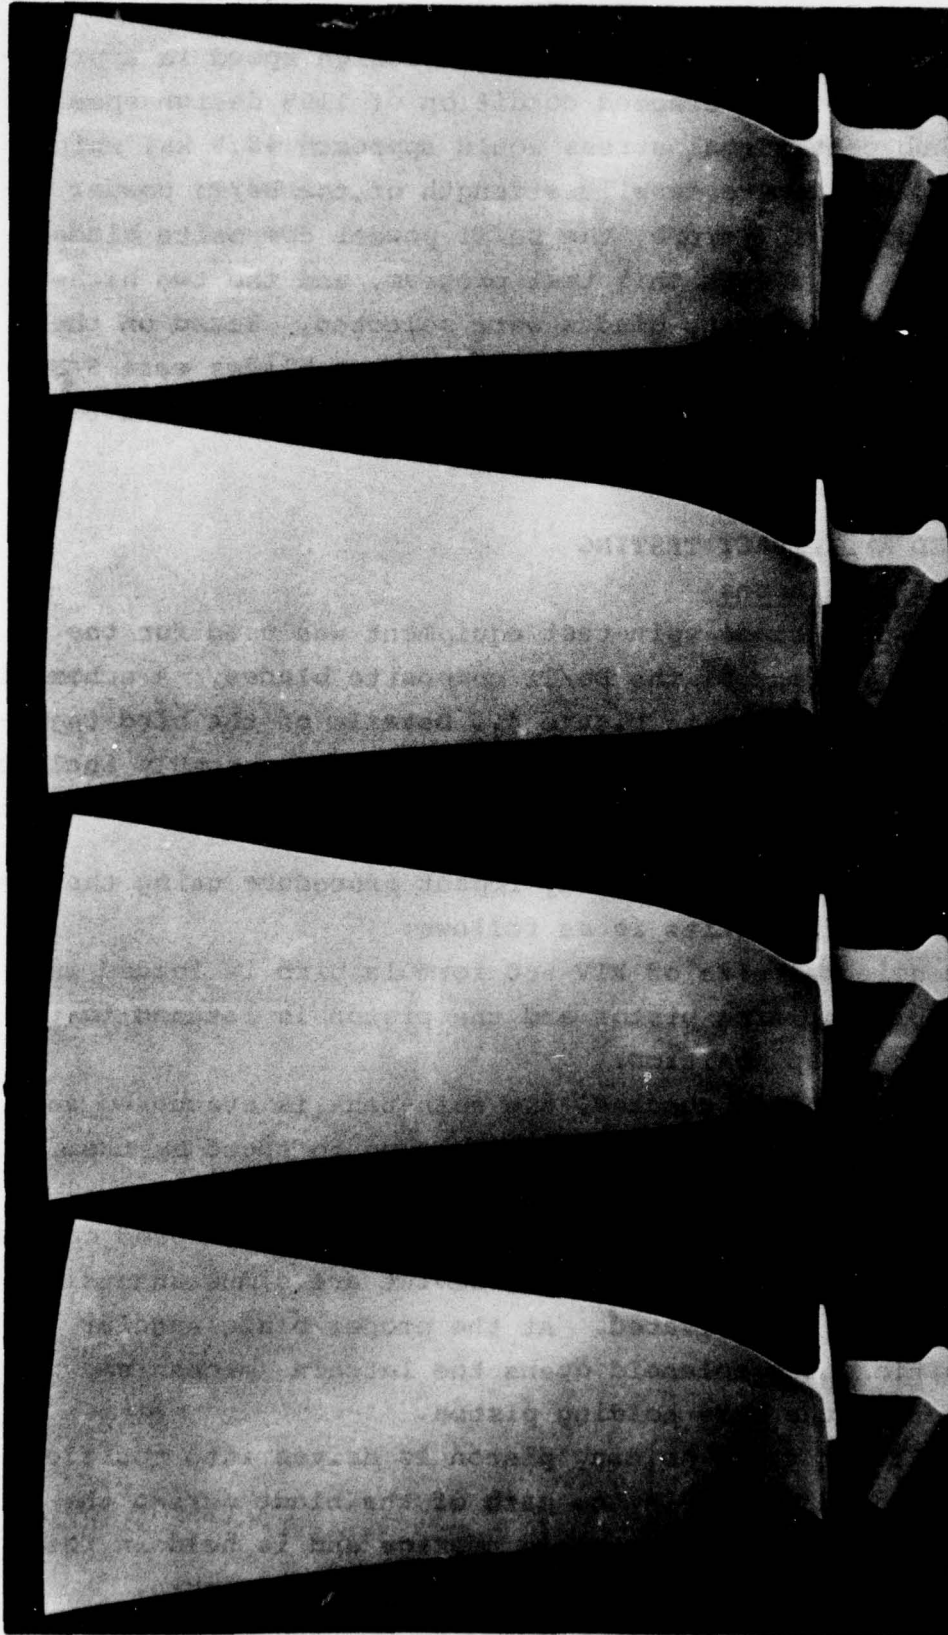
stress at the hub of the airfoil for 100% design speed is approximately 40 ksi. At the overspeed condition of 110% design speed, the average hub centrifugal stress would approach 48.5 ksi which could exceed the ultimate tensile strength of the Be/Ti powder composite airfoil. Therefore, the Be/Ti powder composite blades were eliminated for use in this test program, and the two highest quality Be/Ti rod composite blades were selected. Based on the fluorescent penetrant inspections, the two best blades were S/N E23C-3 and S/N E24-1 with S/N E24-1 being the better of the two (see Figure 3).

Figure 3. Pressure surface of finish machined Be rod/Ti composite fan blades.
(Magn. .4X)

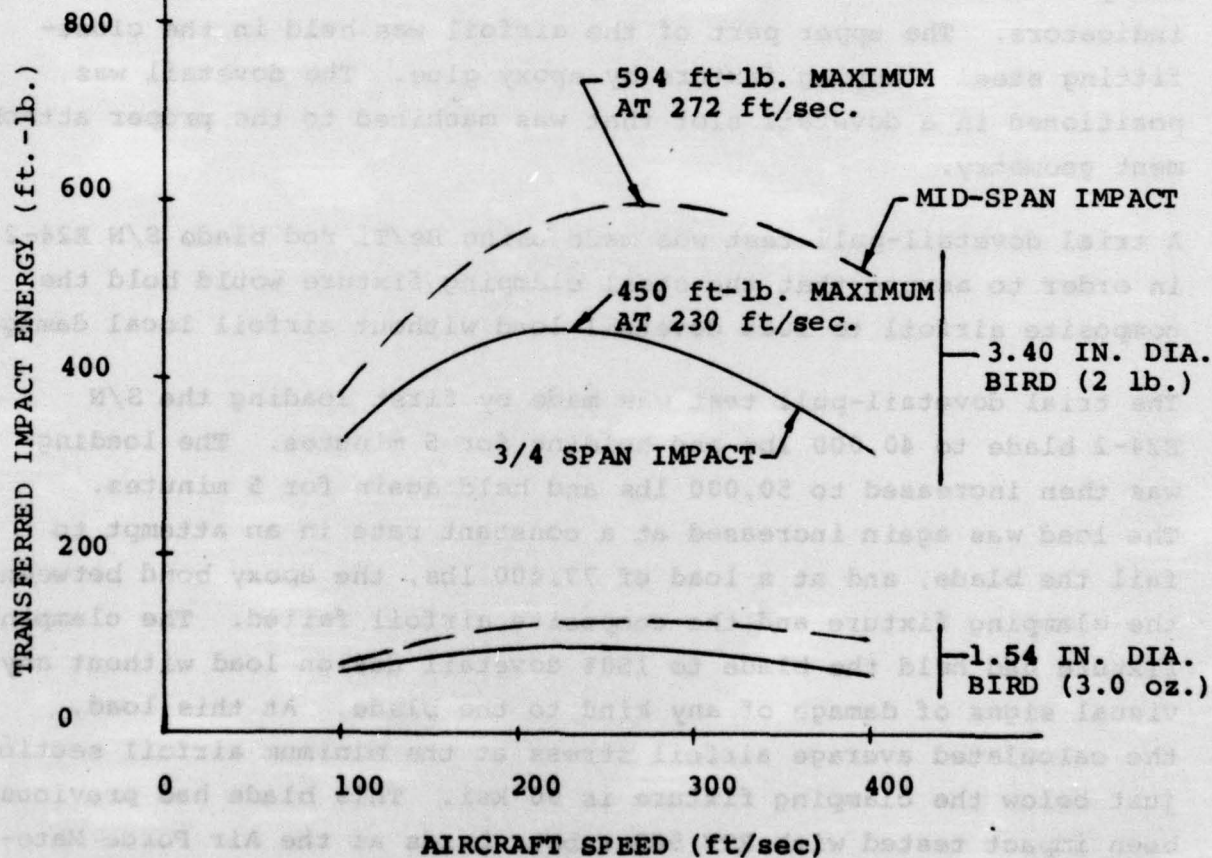
The calculated values of transferred impact energy for the Be/Ti composite blades at 1/2 and 3/4 blade span are shown in Figure 7. Note that the maximum transferred impact energy for a mid-span strike is approximately 30% higher than for a 3/4 span strike. However, the 3/4 span strike was selected as the more critical due to the reduced thickness of the airfoil for local impact strength and due to the larger airfoil root-bending loads that would be induced by the impact at the 3/4 span radius. In addition, softbody impacts are more likely to occur at 3/4 span than at mid-span.

FIGURE 7. TRANSFERRED IMPACT ENERGY vs AIRCRAFT SPEED FOR MID-SPAN AND 3/4 SPAN IMPACTS

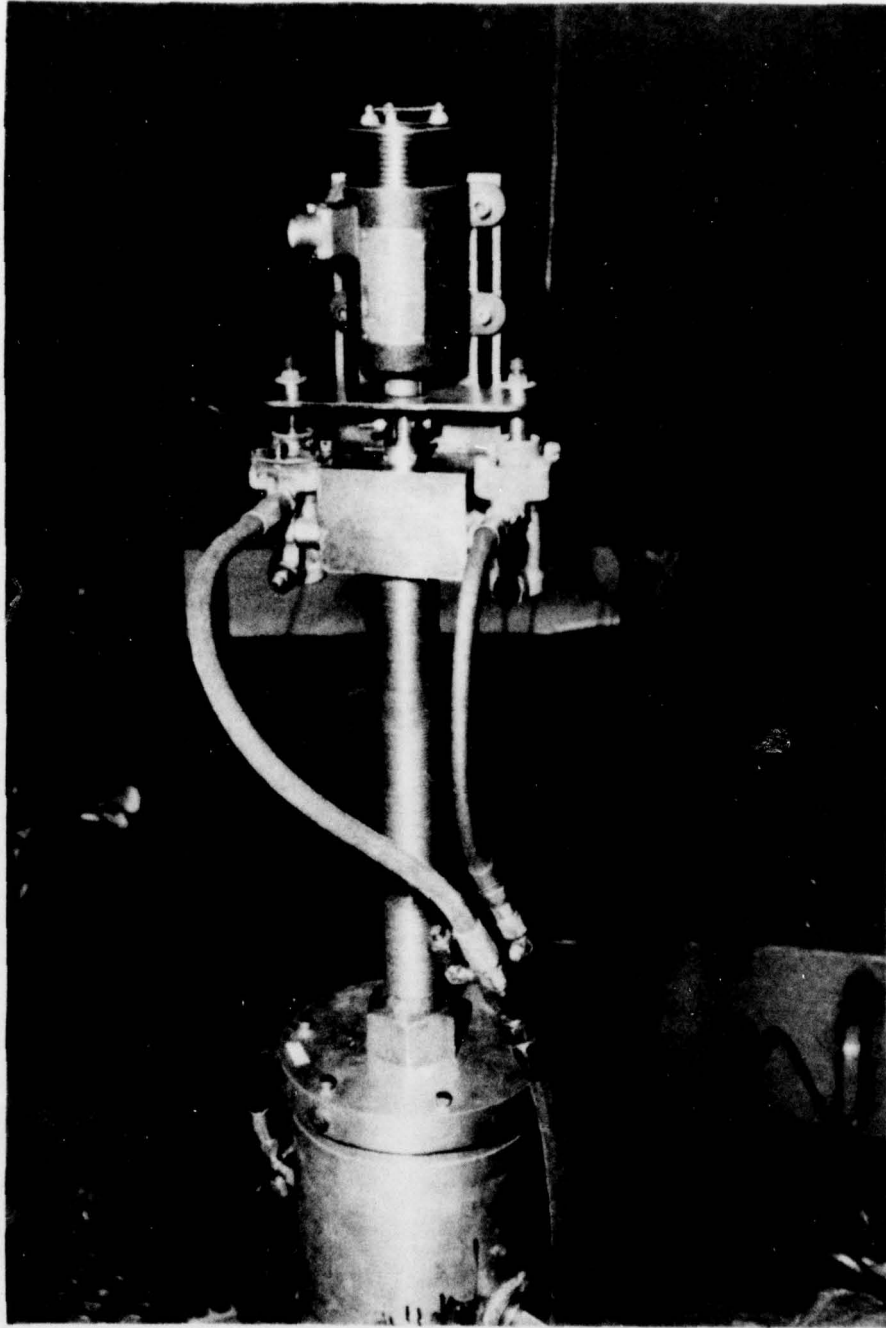
A bench test setup of the bird gun was made in which vibration of the latch mechanism was induced in an effort to duplicate the misfire sequence. Latch disengagement was obtained with about one minute of vibratory load. Following this, a pneumatic latch lock was fabricated and installed on the bird gun as shown in Figure 17. Vibration of the mechanism was again induced and held for five

Figure 17. Modified Bird Injection Gun

minutes without a misfire. The latch lock was then released and the gun was triggered successfully to simulate an actual test shot. this bench test sequence was repeated three times. A new check sheet procedure was formulated to fire the bird gun with no more than a six second delay after the latch lock was released.
